**SOUTHWESTERN COASTAL BASIN
WILTON, CONNECTICUT**

**POPE'S POND DAM
CT 00214**

**PHASE 1 INSPECTION REPORT
NATIONAL DAM INSPECTION PROGRAM**

APRIL, 1980

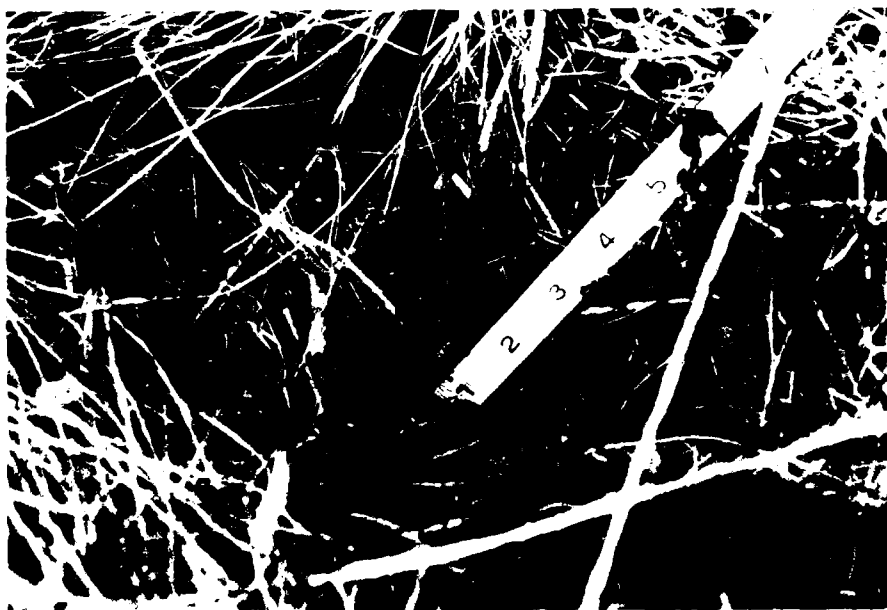
3. **Downstream Face:** The downstream face is an earth embankment and exhibited some signs of moisture fairly high on the embankment. It appears possible that some seepage is coming over the top of the steel sheet piling. Two specific areas of moisture were noted and are graphically shown on the Photo Index (Appendix C). The seepage spots noted are not serious; however, because this is a relatively young dam, these areas should be monitored closely. The face of this dam is free from large trees but grass and wild shrubbery were waist high (Photo C-1). Toe drains were noted on the plans; however, were not visible. An animal hole was noted in the embankment below the dam's east crest (Photo C-10).

C-10 ANIMAL HOLE ON EASTERN
DOWNSTREAM EMBANKMENT

2. The trees and brush on the upstream face should be removed and the animal hole filled.
3. Develop a downstream warning and surveillance plan, including round-the-clock monitoring during heavy precipitation.
4. Joint material should be replaced in open joints where it is missing.
5. Institute a program of annual periodic technical inspection.
